Manhole Inspection Summary

Manhole # S27A__019MH

Insp Date: **12/12/07 11:19 AM**

Location Address: **705 BRUNE ST**

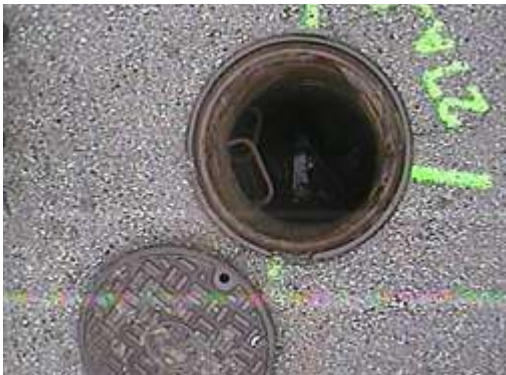
Defect 1

Offset: **1** (in.)

Condition: ☐ Sound ☒ **Cracked** ☐ Leaks

FRAME OFFSET/ CRACKED FRAME

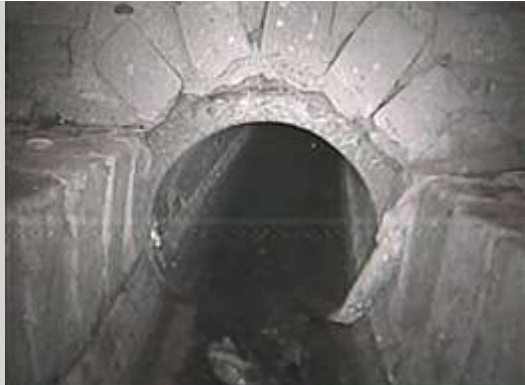
12 O'Clock Outflow

8 in. Circular Gravity Sewer
Pipe Out @ 12 O'Clock

Pipe Height: (in.) Direct
Pipe Material: **Clay** ☐ Pipe Lined
Invert Depth: **11.61** (ft.) Flow Characteristics: **Slow**
Deposits: ☒ None ☐ Mud ☐ Sludge ☐ Debris ☐ Grease
Silt Depth: (in.) Deposits Extent:
Infiltration: **None** Pipe Seal Cond: **Sound**

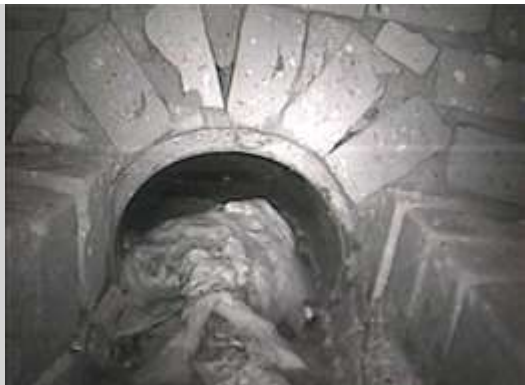
3 O'Clock Inflow

8 in. Circular Gravity Sewer
Pipe In @ 3 O'Clock

Pipe Height: (in.) Direct
Pipe Material: **Clay** ☐ Pipe Lined
Invert Depth: **9.95** (ft.) Flow Characteristics: **Slow**
Deposits: ☒ None ☐ Mud ☐ Sludge ☐ Debris ☐ Grease
Silt Depth: (in.) Deposits Extent:
Infiltration: **None** Pipe Seal Cond: **Sound**

Drop: **Outside Direct**

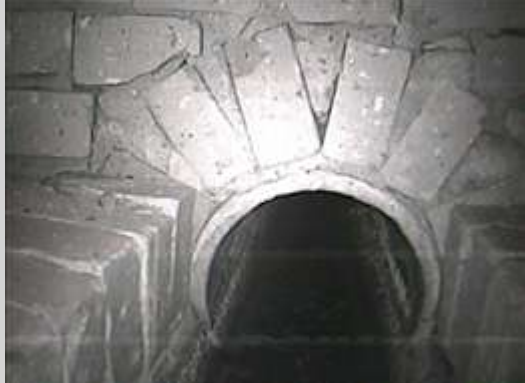
6 O'Clock Inflow

8 in. Circular Gravity Sewer

Pipe In @ 6 O'Clock

Infiltration: **None** Pipe Seal Cond: **Sound**
